## **Early History of Dredging**

# Dredging

#### How dredging works

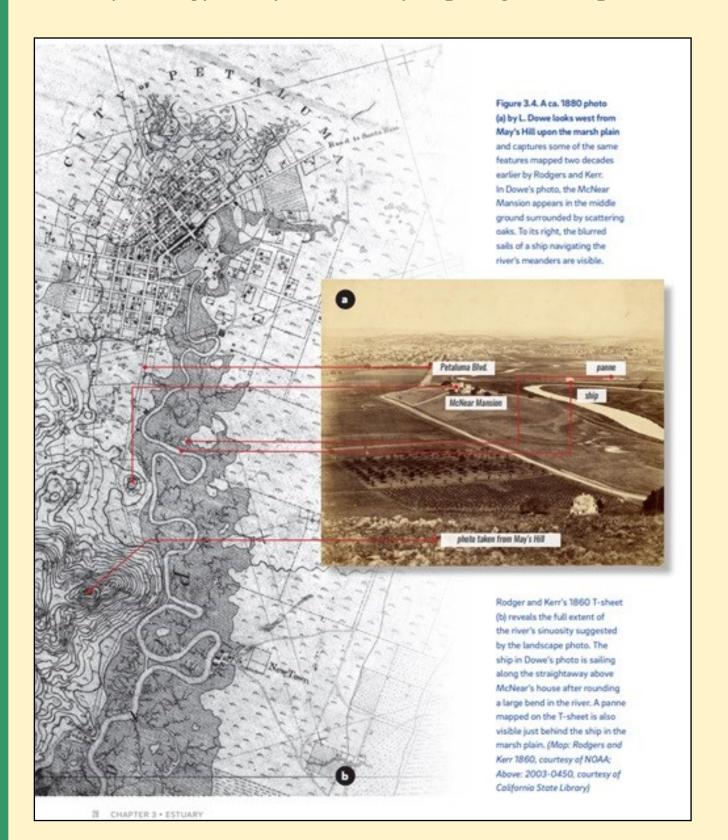
Besides straightening of upper river many dikes were erected to channel the water and create cropland in prior marshland, especially in the lower river. The diagram below from the SFEI historic hydrology study is an early topological map that shows the sinuosity of the upper river.

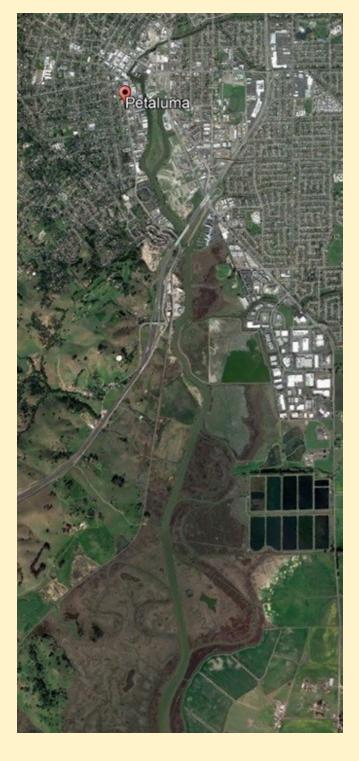
This Google Earth satellite image (below left) of upper Petaluma River shows where straight cuts were made. The prior curves become part of the marsh but are still visible due to different soil and vegetation. You can see dark brown areas were the river used to run that are now part of the marshland or mudflat areas.

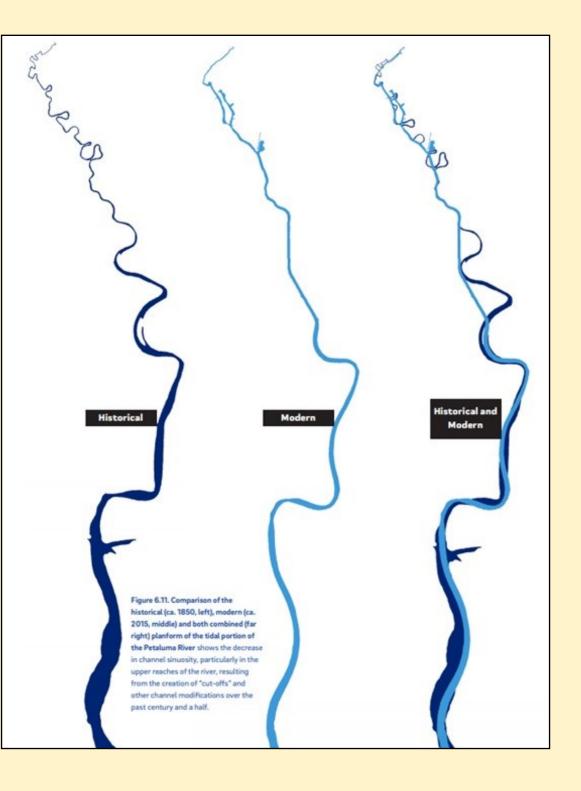
The diagram from SFEI historic hydrology study (below right) shows how the river was changed over time. Water now moves faster in a narrower channel carrying more sediments further. Kayakers need to be careful when the water is moving fastest at mid-tide times in the lower reaches.

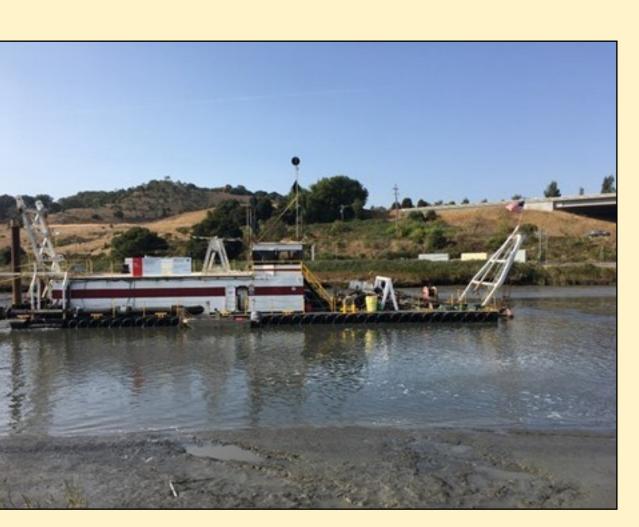
Fig.: Cutter Suction Dredger working near 101 overpass.

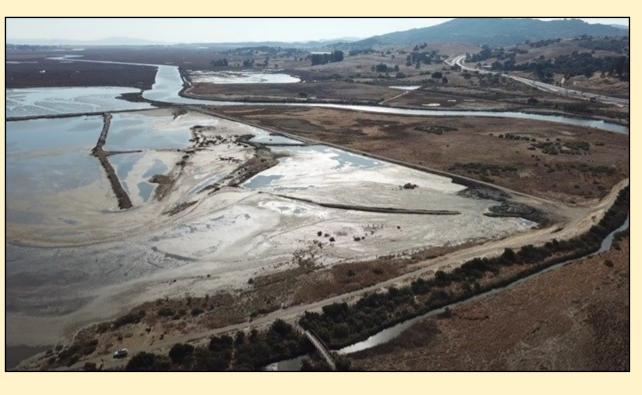
Fig.: Dredge Spoils are deposited on the western side of the Central Pond . Dikes channel and slow the flow.

Images to left show the Shollenberger Central Pond filled with dredge spoils in 2021. Most of the sediment and trash dropped out of the pipe on the west side near the river. Dikes were set up to slow the water and spoils so sediments drop out and water can move to other side where it is released back to river.

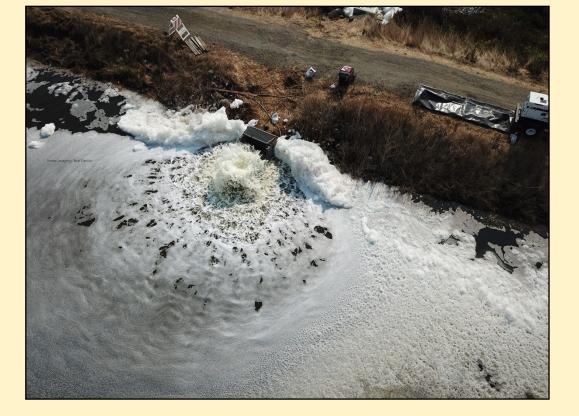
Fig.: After sediment settles, water is aerated before being released back to the river to meet water regulations.

At this point the sludge is about 10 - 15 percent sediment, and the rest is river water. In 2003, birds gathered around the dredge outfall because it was very rich in fish and invertebrates which they eat immediately and for many months following. Mammals such as river otters, muskrats, raccoons and skunks may also join in the feast. The scraps from this feast quickly degrade to detritus, which enriches the water to stimulate plant and invertebrate growth. If the pond becomes too full, some of the water will be skimmed (decanted) from the surface after the sediment has settled. This decanted water is released through water gates into Adobe Creek, which returns it to the river or aerated and passed onto mudflats.

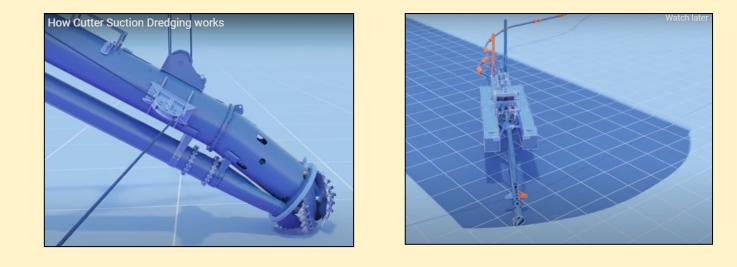
Fig.: Left image shows drill cutting the bottom with cables moving it side to side. Right image shows pattern as barge pivots side to side slowly moving upriver using the alternating tall pilings in the front.

A dredger boat has some unique features. A "blender" 3 to 4 feet in diameter and many feet long chops up sediments as it slowly sweeps back and forth. A stream of surface water is constantly added to dilute the mixture of water and spoils. The resulting slurry is then pumped through a flexible pipe system up to three miles long and 24 inches in diameter. For years, this process delivered sludge to the Shollenberger Central Pond, officially an industrial waste site. Dredge spoils can be used as landfill and engineered soils for roads and dikes.

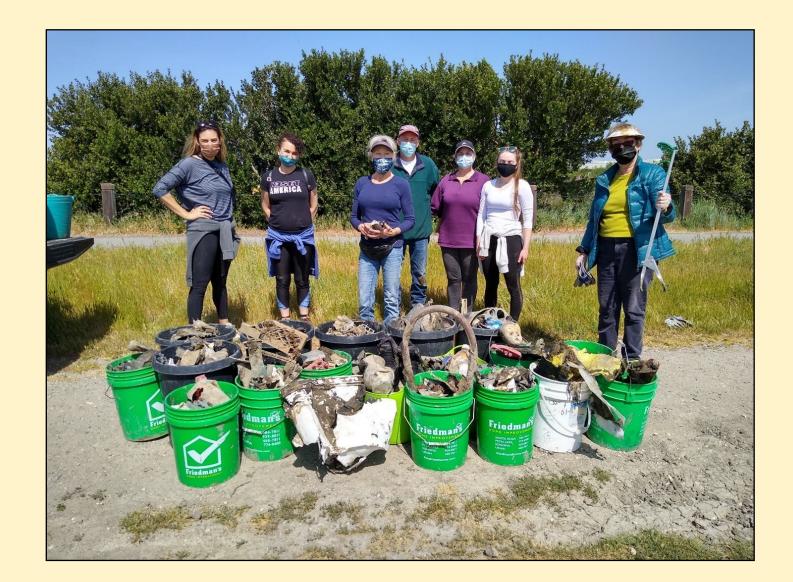
**Trash** of all sorts come out with the recent dredge spoils including small plastic bits, bottles, plastic bags, crate parts, tires, toys, balls, dock floatation, boat parts, and even car parts. Future dredging will need to collect this human made debris before deposition. PWA led the community effort to pick up the debris from the Central Pond surrounded by the Shollenberger Park walkway. Over 14 sessions of 2 hours each were organized and an average of 10 volunteers joined the effort each day. On each day, a pickup truckload was removed.
